Army Missile Command  
Redstone Arsenal, Alabama

TECHNICAL REPORT  
RL-72-19

MIGRATION OF SILVER THROUGH GOLD PLATING  
ON ELECTRICAL CONTACTS

December 1972

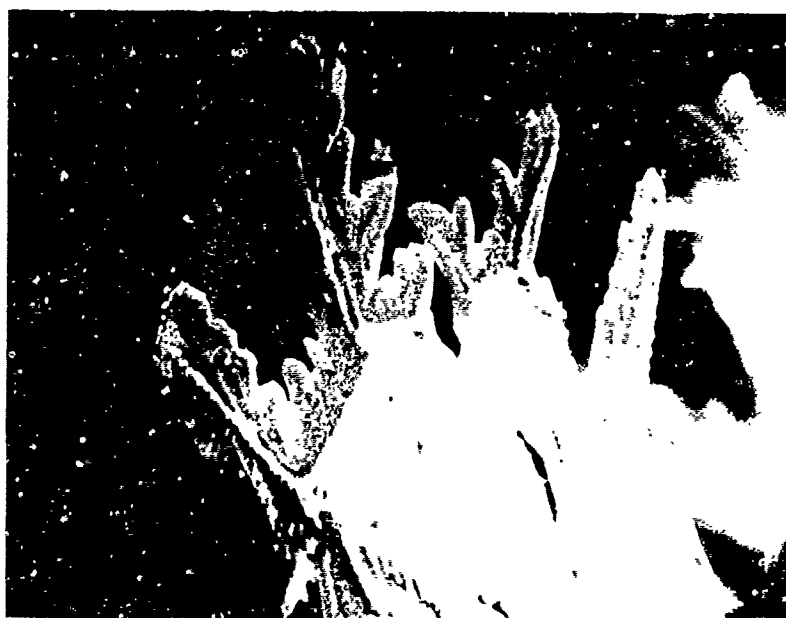
FIGURE 20. ELECTRON MICROGRAPH. EXHIBITS A CORAL-LIKE STRUCTURE OF SILVER/SILVER SALT CRYSTALS. MAGNIFICATION 1300X.

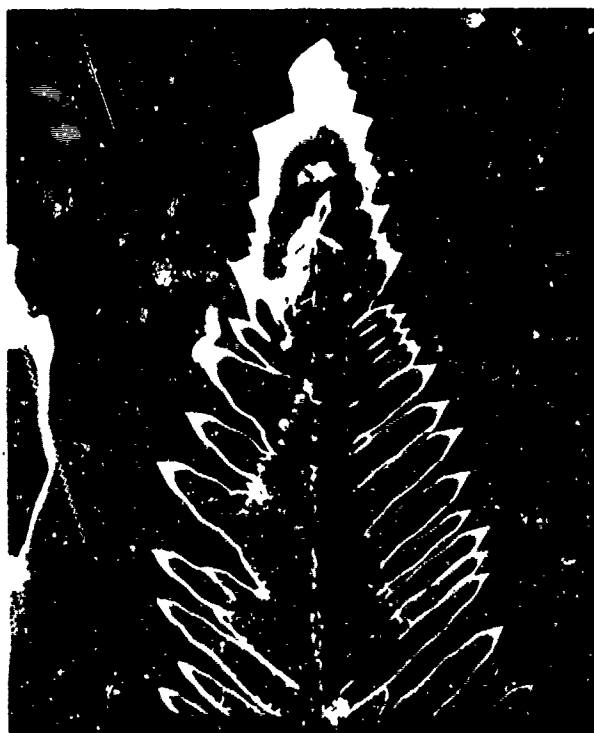
FIGURE 26. ELECTRON MICROGRAPH.  
SHOWS THE TOP OF THE CHRISTMAS  
TREE (FIG. 25) WITH BEAD DECORA-  
TION AND FLOWER JUST BELOW  
THE TIP. MAGNIFICATION 500X.

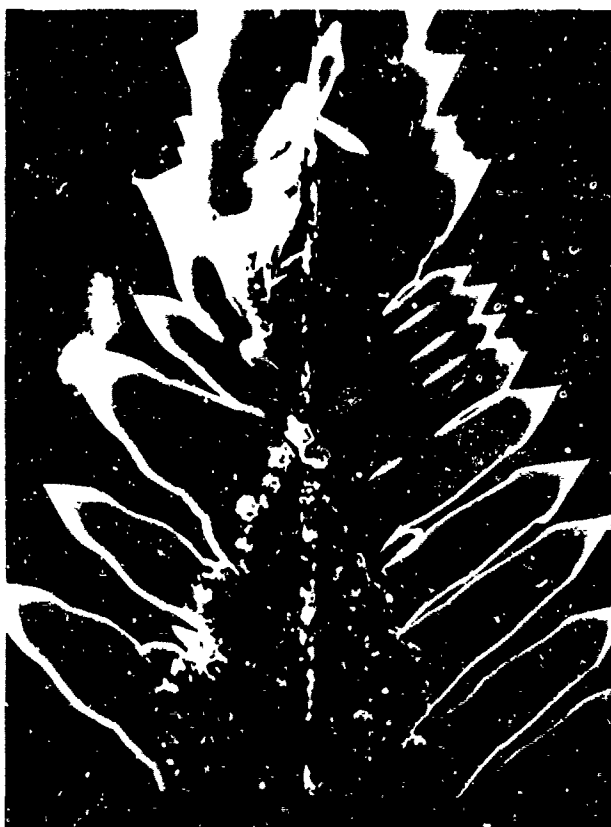
FIGURE 27. ELECTRON MICROGRAPH.  
THE CHRISTMAS TREE (FIG. 25)  
EXHIBITS THE BEADED AREA  
LOOKING MORE LIKE ROUGH  
DIAMONDS WITH THE FLOWER  
AT THE TOP AN ORCHID.  
MAGNIFICATION 1000X.

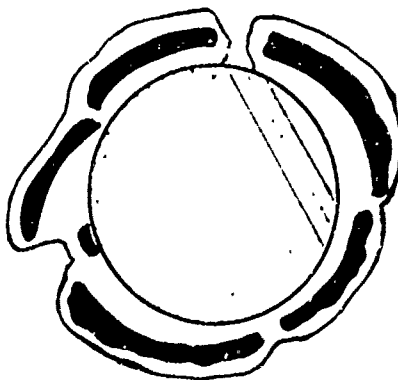
In order to define the plating layers of the two differently plated pins, i.e., silver and nickel underplates, both were sectioned and mounted. However, problems arose when attempting to polish the mount. The gold layer, being soft, tended to smear so that a clear picture of the underplate could not be obtained. Subsequently, in order to anchor the plate, the pins were overplated with electroless nickel. But this procedure did not help the situation with the badly corroded pins because apparently the silver layer had almost completely migrated, leaving the gold layer as a shell very loosely adhered to the brass core. The electroless nickel plating caused a complete detachment of the gold, as illustrated by Figure 41, wherein the cross-hatched center is the pin. The broken dark pieces are gold plate, and the light area surrounding it all is electroless nickel plate that has filled in the voided area and overcoated the gold pieces.

**FIGURE 41. PHOTOGRAPHED SKETCH. AN ILLUSTRATION OF A BADLY SILVER MIGRATED PIN ELECTROLESS NICKEL PLATED TO CAPTURE THE LOOSELY ADHERED GOLD PLATING. CENTER: PIN, DARK PARTICLES: GOLD PLATE; OUTLINED SURROUNDING LIGHT AREA: ELECTROLESS NICKEL PLATE.**
